# ***Integrity Management Process of Tension Leg Platforms***

## ***Final Report***

***BSEE Project Number: E17PC00018***

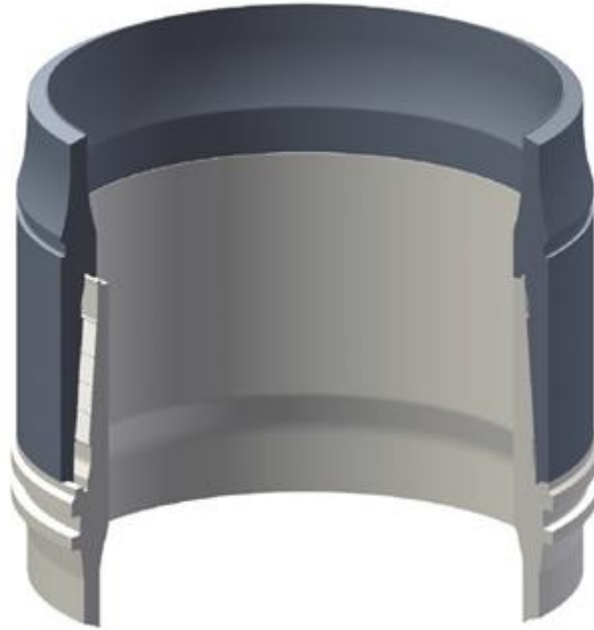
**Figure 2.4 - Merlin Tendon Coupling (© Oil States Industries, Inc.)**

The earliest TLP's used screw thread couplings or single piece continuously welded tendons, but starting with Auger in 1994, all GOM TLP's have used a tapered, non-helical, grooved thread coupling derived from a casing connector which cannot come un-screwed. This was first developed by Oil States Industries (OSI) for Shell Oil and known as the Merlin Coupling (see Figure 2.4), but has since been further developed by others (GMC - Intermediate Tendon Connector - ITC). The pin and box, when first initially assembled, are limited to not engaging the last thread due to the taper of each, and the interference of the threads. A preliminary metal-to-metal seal at the root and tip of the pin section allows the introduction of high-pressure hydraulic fluid into the threaded region, which squeezes the pin and stretches the box, allowing the connector pair to be forced together to its final engagement position. Relaxing the hydraulic pressure allows full engagement of the threads, which form a strong, non-rotating bond. Ideally, the connector is reversible, but disassembly has not been attempted on any tendons after years in place. The big concern in removal is the ability of the seals to hold hydraulic pressure after years of exposure to seawater.

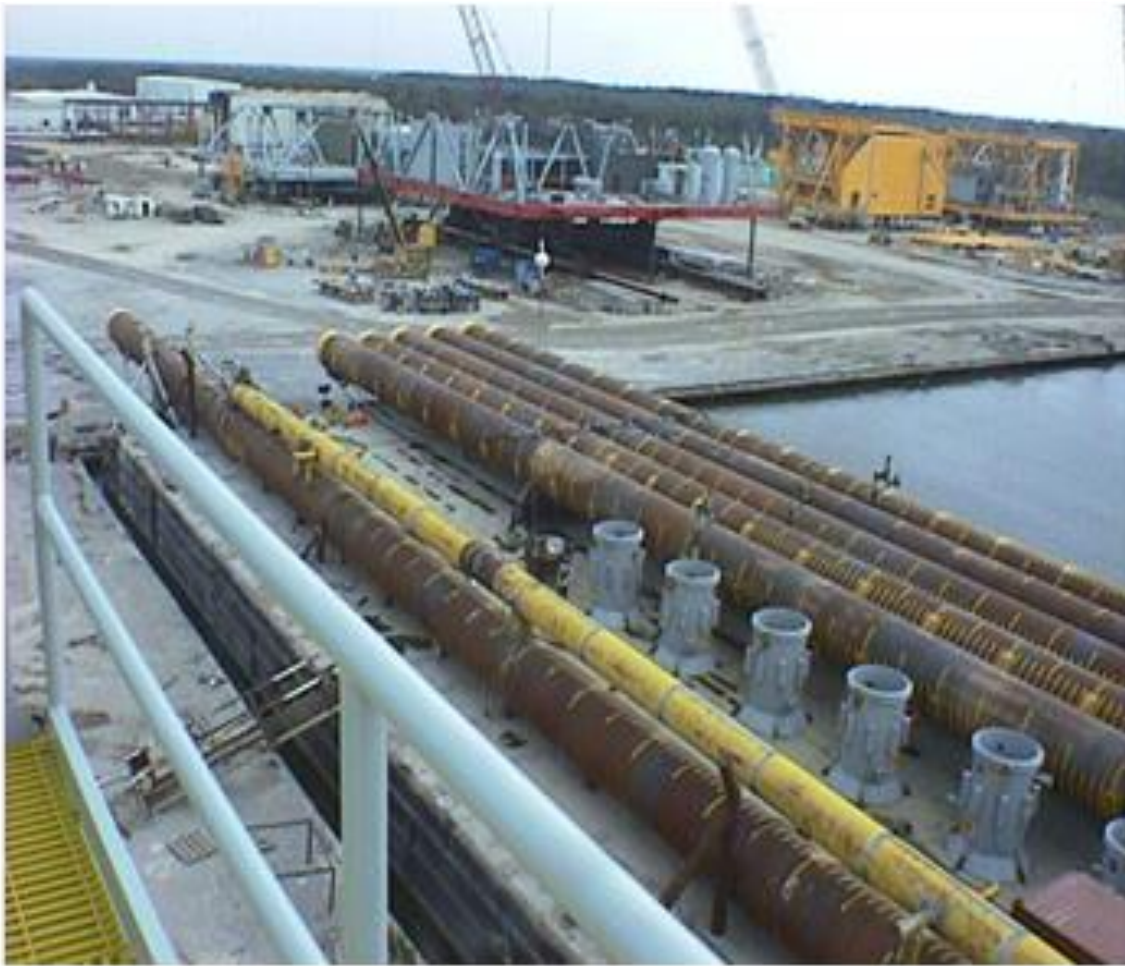
**Figure 2.6 - Piles with receptacles attached. The CP anode sleeves shown are installed after pile driving. (Photo courtesy of ENI)**

The driven foundation piles for GOM TLP’s are typically 72” – 96” diameter, and are 300 to 430 ft. long. The receptacles are generally 60-72” diameter, and are configured for the roto-latch or snap ring connector styles (see Figure 2.6). If the pile and receptacle are differing diameters, a tapered transition is used between them. Because of the stresses during pile driving, and because they are not easily inspectable, the piles and receptacles are generally designed to operate at much lower stresses than the tendon itself, and have very long fatigue lives.
